## BEST ENVIRONMENTAL PRACTICES FOR THE HOTEL INDUSTRY

### CANDLES HOTEL

Aqaba, Jordan

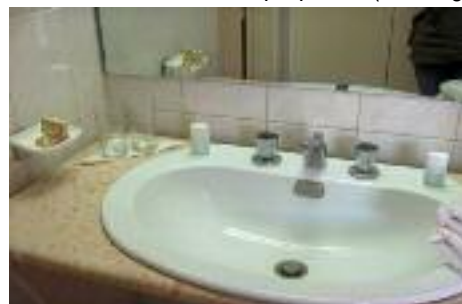
The hotel uses brackish water from a well for toilet flushing and the pool (800 m<sup>3</sup>/year), a mix of brackish water and water from the municipal network for the showers and water from the municipal water network for all other purposes (drinking, kitchen, laundry, etc.). The brackish water is softened prior to utilization in order to reduce the content of total dissolved substances (TDS). The pool water is treated with chlorine and is filtered continuously by two sand filters. The filters are backwashed eight times per day and the backwash water is sent to the sewer. A lot of water is needed to fight cockroaches and rats through flushing hot water with chlorinated (3 ppm) in the pipes. The management also reports misuse by guests. Until now there has been no implementation of water saving measures because most of the water is free (brackish). There are no mixers on taps and showers as shown in Figure 1. Toilets are single flushed. Water consumption in each department is measured to identify hot spots (pool, kitchen, etc.).

Fig. 1: room taps without mixers

Environmental objective	Action & means	Expected results	Investments	Annual savings
Reduce water consumption in rooms without cutting on guest's comfort, enabling also to tackle calcification problems in pipes	<ul style="list-style-type: none"> <li>Install flow regulators on the showerheads in rooms in order to decrease consumption from 18 to 8 litres/minute</li> <li>Install water-reducing filters for taps in rooms in order to decrease consumption from 18 to 8 litres/minute</li> </ul>	<ul style="list-style-type: none"> <li>Reduction by about 50% of the shower flow rate</li> <li>Reduction by about 50% of the tap flow rate</li> <li>Reduction of calcification problems in pipes</li> </ul>	4'600 JOD	36'100 JOD
Reduce the gas, electricity and water consumption of the hotel by replacing the old washing machines	<ul style="list-style-type: none"> <li>Install two new energy-efficient laundry machines</li> </ul>	<ul style="list-style-type: none"> <li>Reduction of electricity, gas and water consumption</li> <li>Reduction of wastewater generation</li> </ul>	710 JOD	250 JOD

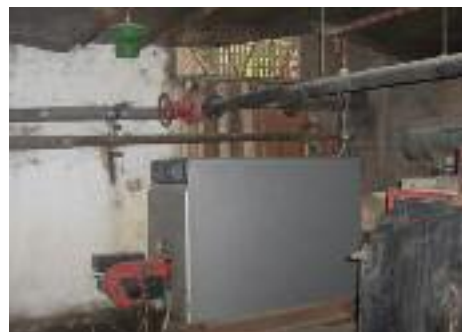
Air conditioning in the rooms and hotel departments is provided by modern split units. Lighting is provided by fluorescent lamps instead of classic light bulbs. When a guest leaves his room, the power is switched off by the reception, thus saving energy. The kitchen refrigerators situated in front of the ovens have thus a reduced cooling efficiency. Hot water for domestic use is produced using two diesel (low quality diesel with high sulphur content) boilers as illustrated in Figure 2. The water pipes in the boiler room are not insulated but the hot water lines throughout the building are self-insulated (polyurethane). Maintenance of the boiler is undertaken annually, but its efficiency was never measured. Heating of the building is provided by the same split units that cool the hotel during the hot season. According to the manager, double-glazing is too expensive. Heat for cooking and for the provision of hot water in the kitchen, in the laundry and in the restaurant (buffet) is provided by the burning of liquefied petroleum gas (LPG) cylinders. Electricity is believed to be the most important energy consumption as it provides cooling, heating and lighting.

Fig. 2: diesel boiler
